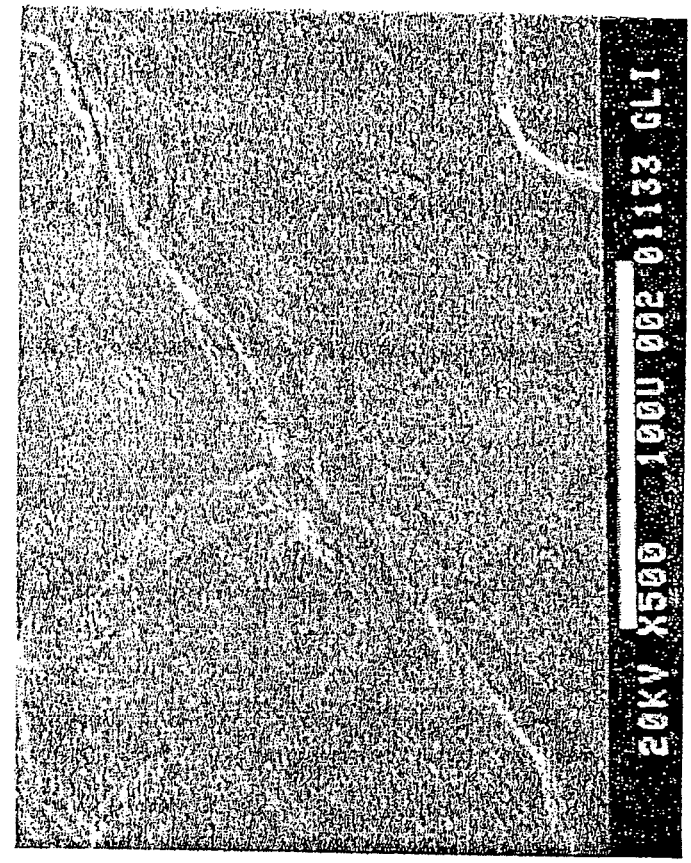
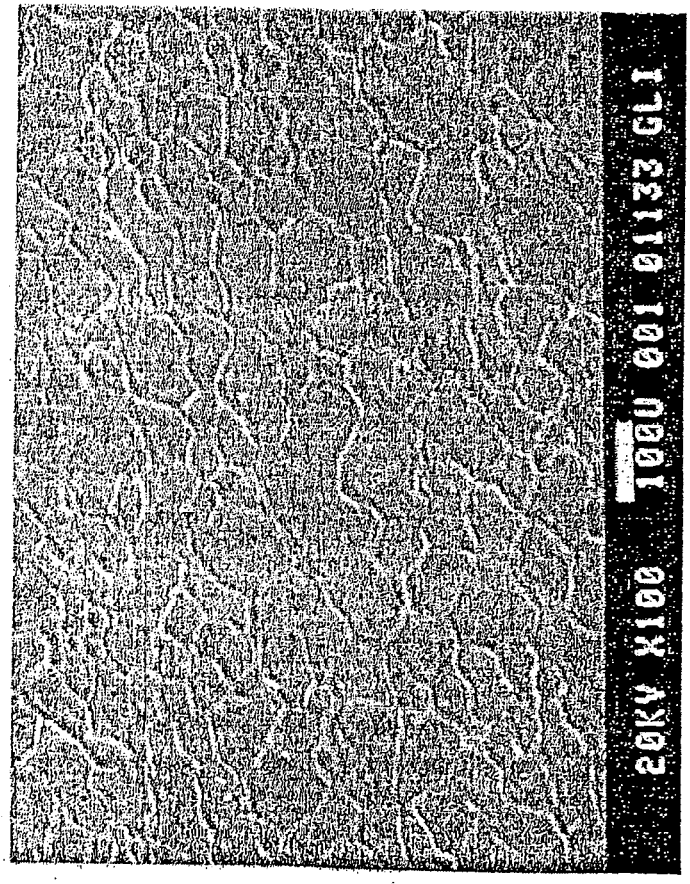
Fig. 1

- Coupon was heat treated, no sol coating
- Coupon tested for hot corrosion for 1000 hr
  - 960 C, 1 atm, 17% H_2O, 2.5% O_2, 23% CO_2, bal N_2
